**Rig Name:** N. Sea location  
**Rig Type:** Semi-Submersible  
**Owner name:** N. Sea location  
**Classification Society:** ABS

**Project description:** To assist in reviewing previous, partial strengthening fix of the unitized structural framing, that caused failure on the side outlet against latest failure (reoccurrence). Then do necessary investigation and structural analysis to ensure that structural modification, if additionally required, is executed to conclusion. This is in order to avoid recurring of this side outlet failure. It is thought that the load path when landing the 215 Te BOP on the angel wings has caused the load to channel to the choke and kill line's side outlets.

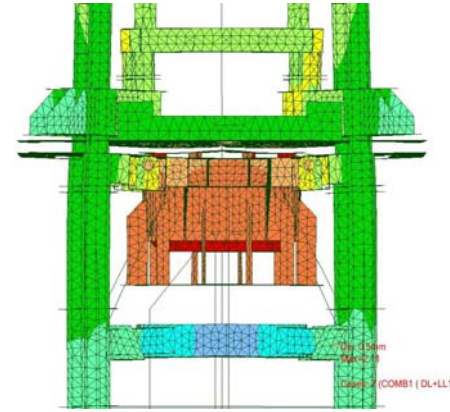
Deformation Plot Under Load

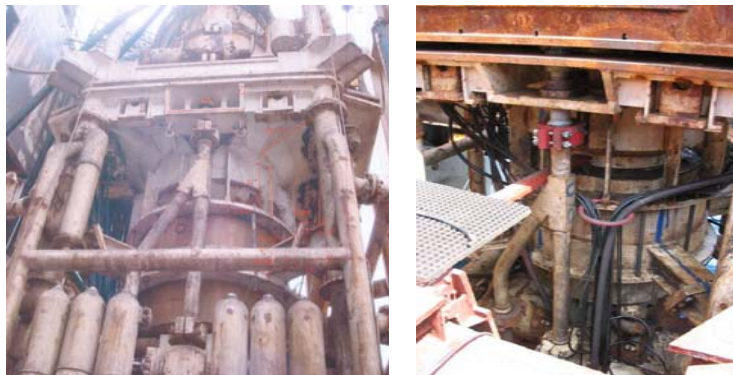
General View

Close Up View
